DEFENDANTS' EXPERT WITNESS DISCLOSURES

Donan Engineering was retained to conduct an inspection and create a written report of its findings regarding alleged hail and wind damage at Plaintiff J&S Welding, Inc.'s ("J&S Welding") property located at 2579 North 9th Avenue, Humboldt, Tennessee 38343 (the "Property").

OCTOBER 6, 2021

Burr Forman Claim No: 23930877
Envista Matter No: MAT-141908-G4Z7
REPORT DATE: January 6, 2023

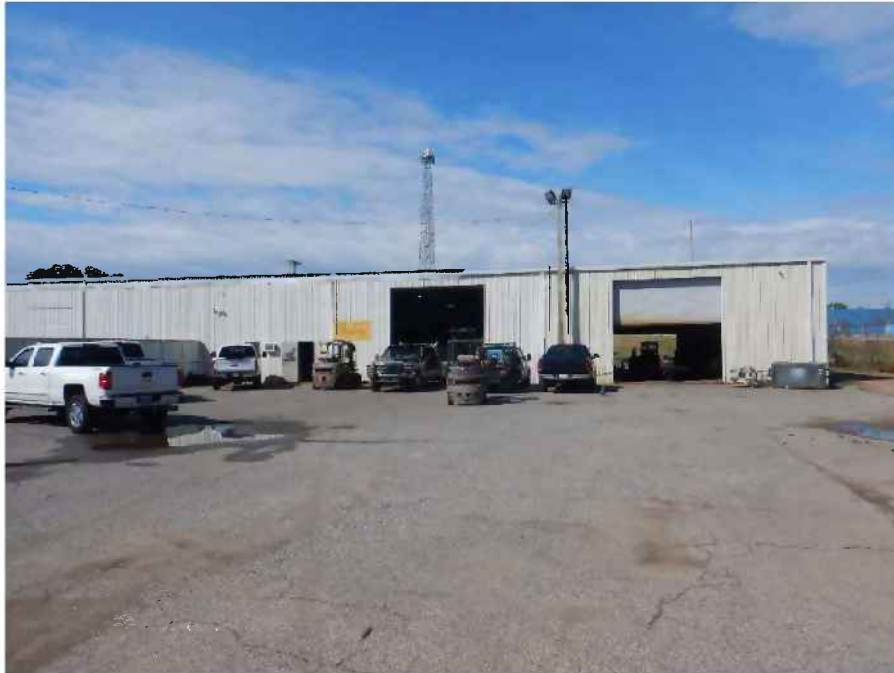
Photograph 1: Building facing east.

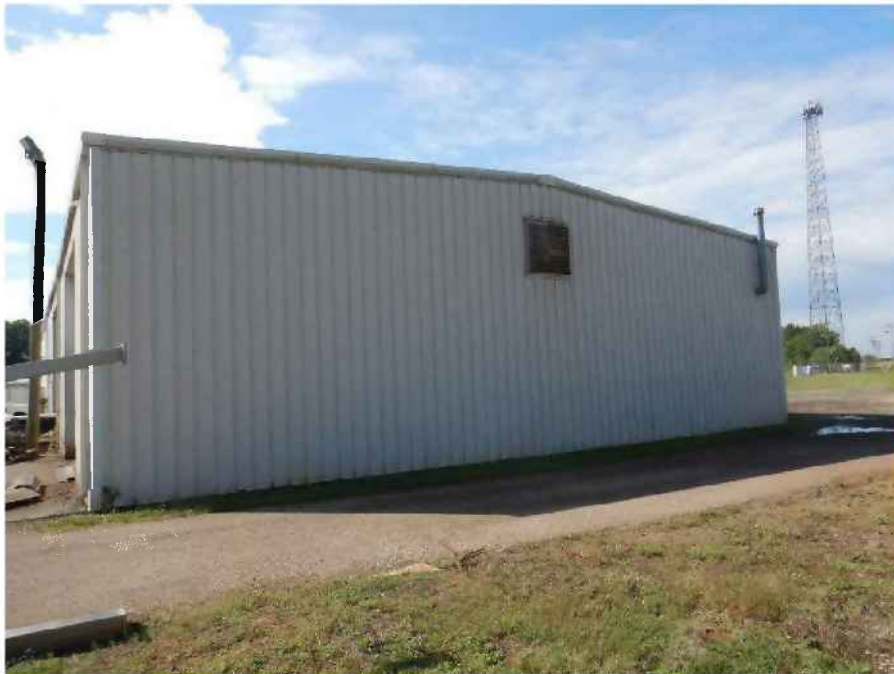
Photograph 2: North side of building.

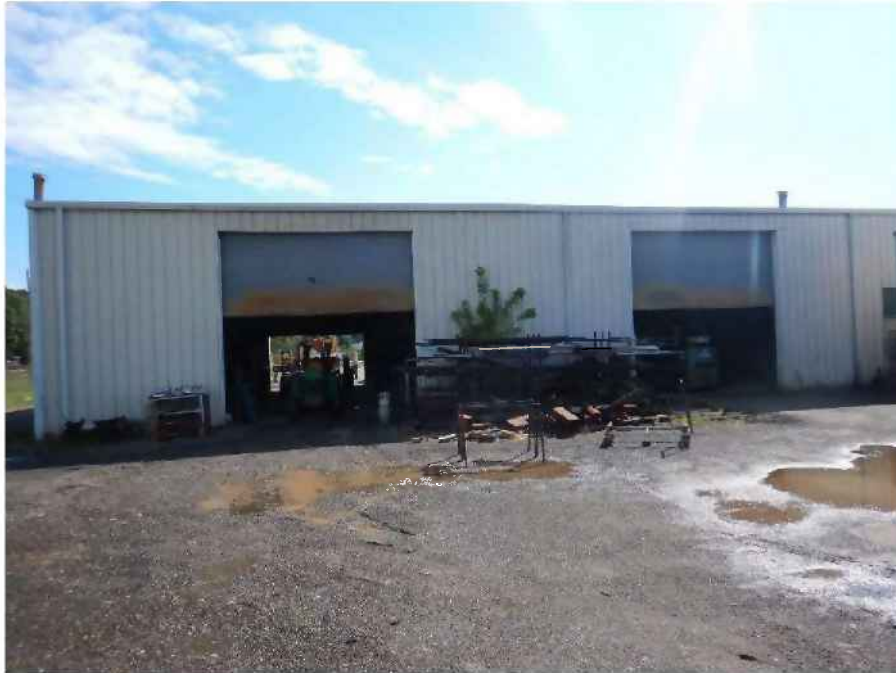
Photograph 3: West side of building.

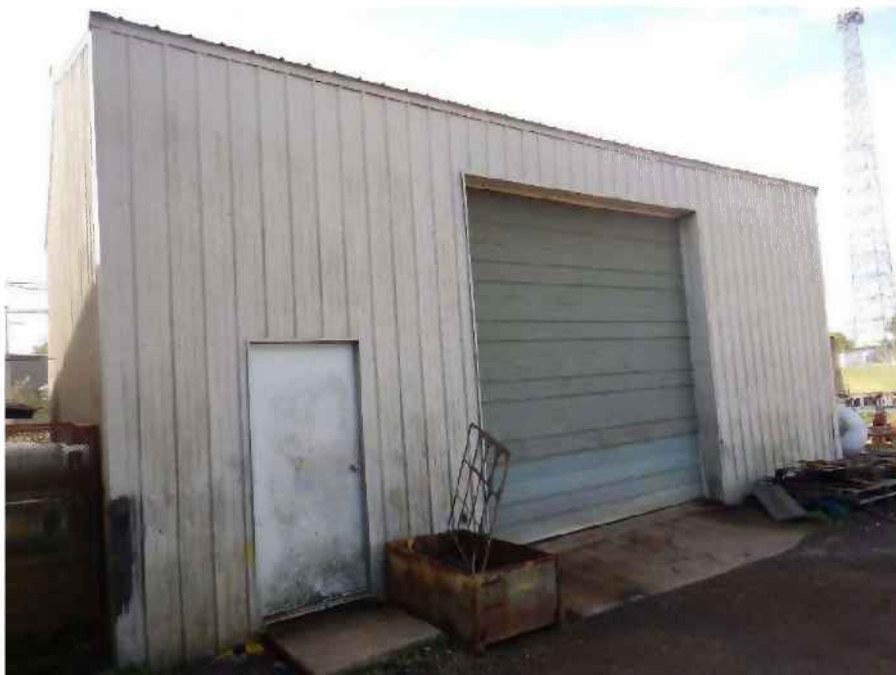
Photograph 4: North side of smaller building.

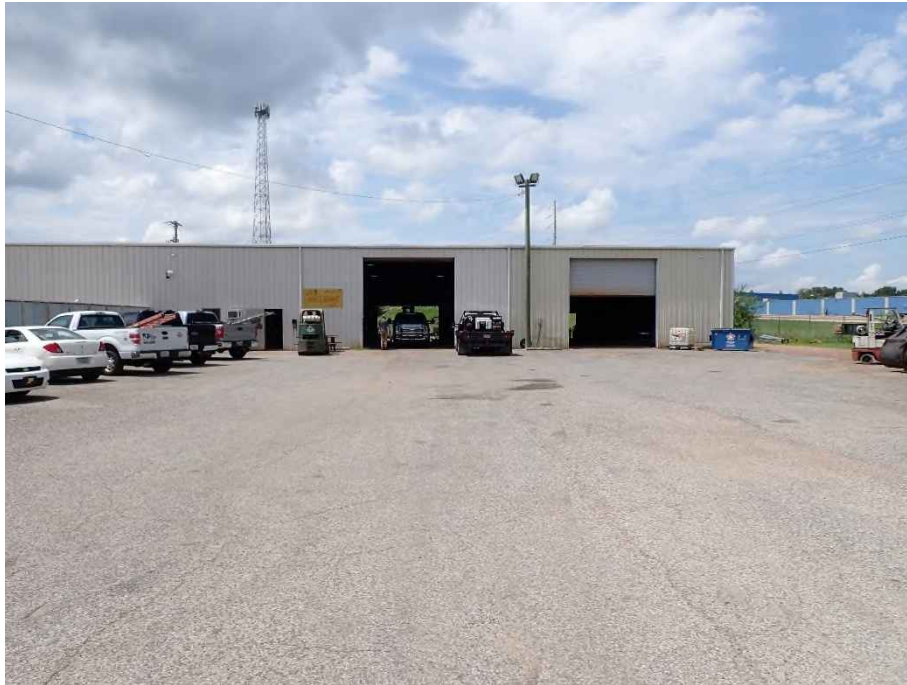
Photograph 1.

View of the front of the building facing east toward North 9th Avenue.

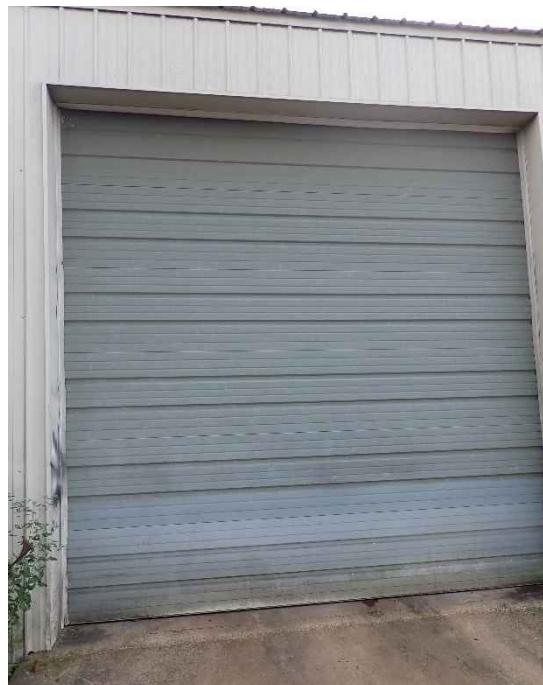
Photograph 2.

View of an overhead door.

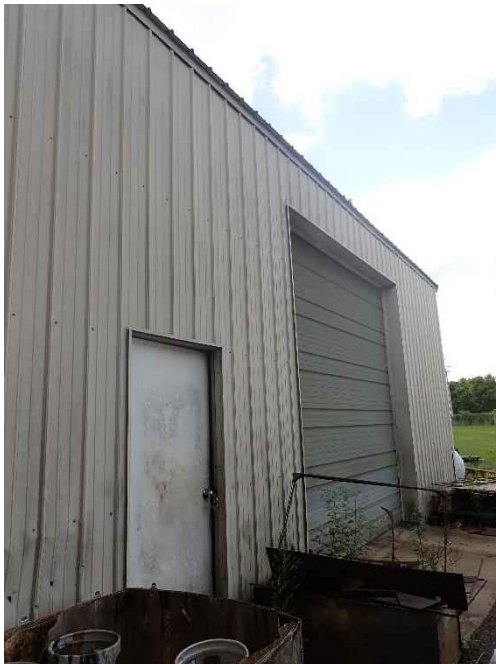
Photograph 4.

View of building #2.

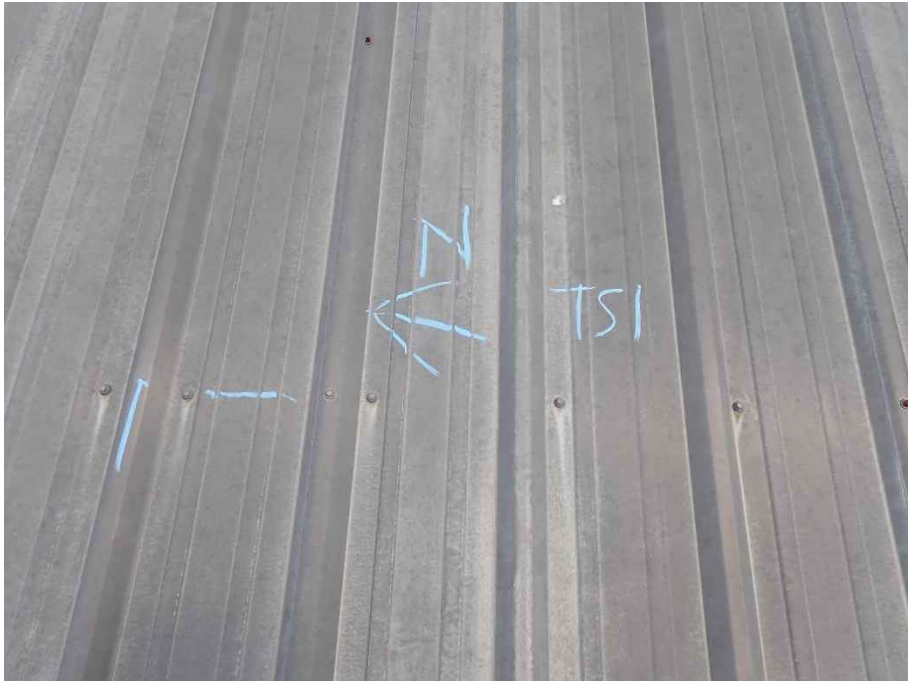
Photograph 10.

View of test square #1.

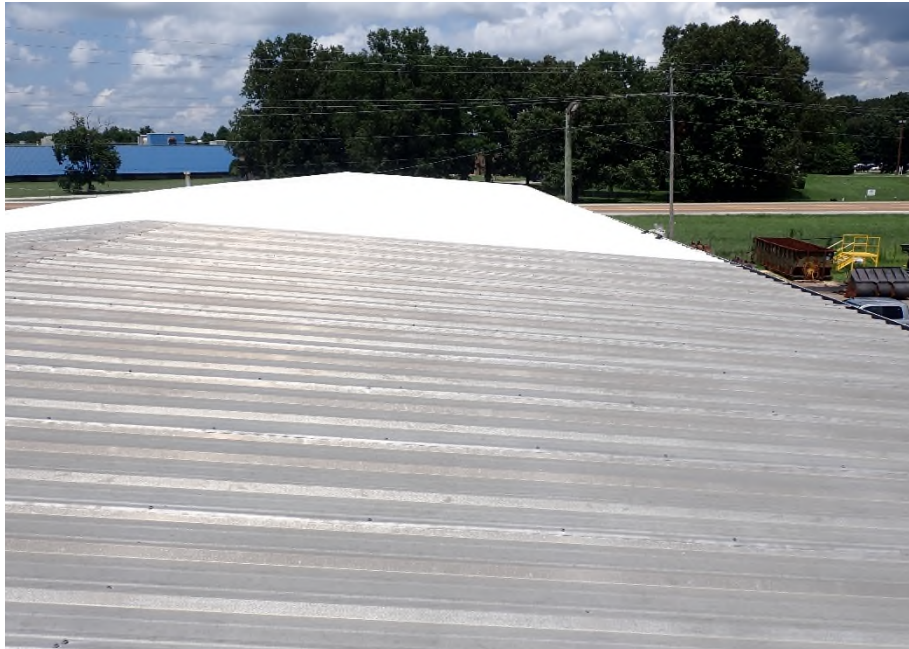
Photograph 16.

View of the roof covering building #1.

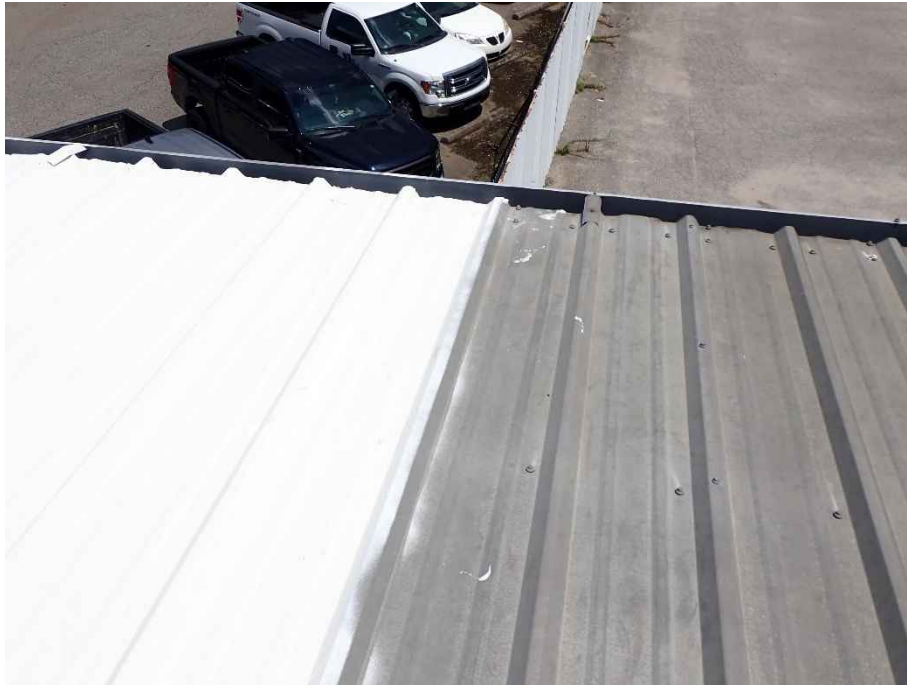
Photograph 17.

View of the roof covering building #1.

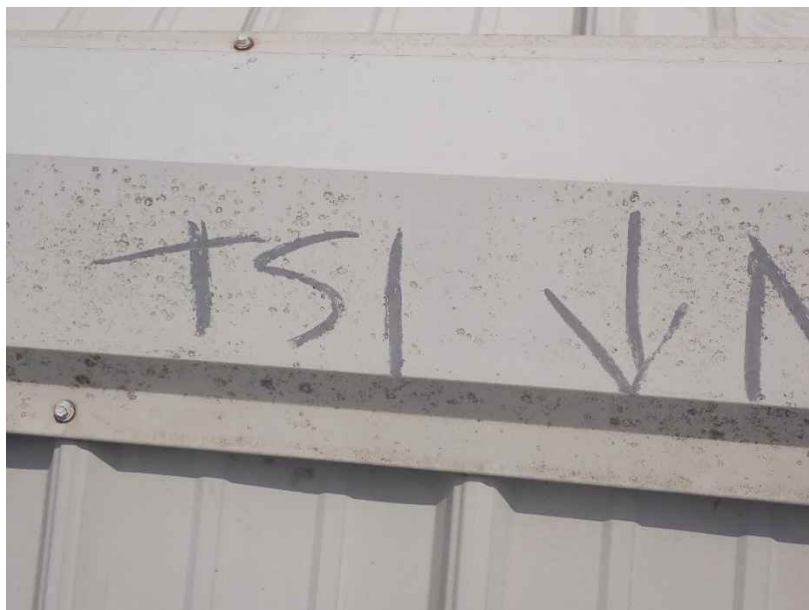
Photograph 26.

View of test square #1 for building #2.
